Investigation of a 1-Ton Tank-Car Tank That Leaked Phosgene in Easton, Pennsylvania on April 24, 1973

C. G. Interrante

April 1975

Failure Analysis Report

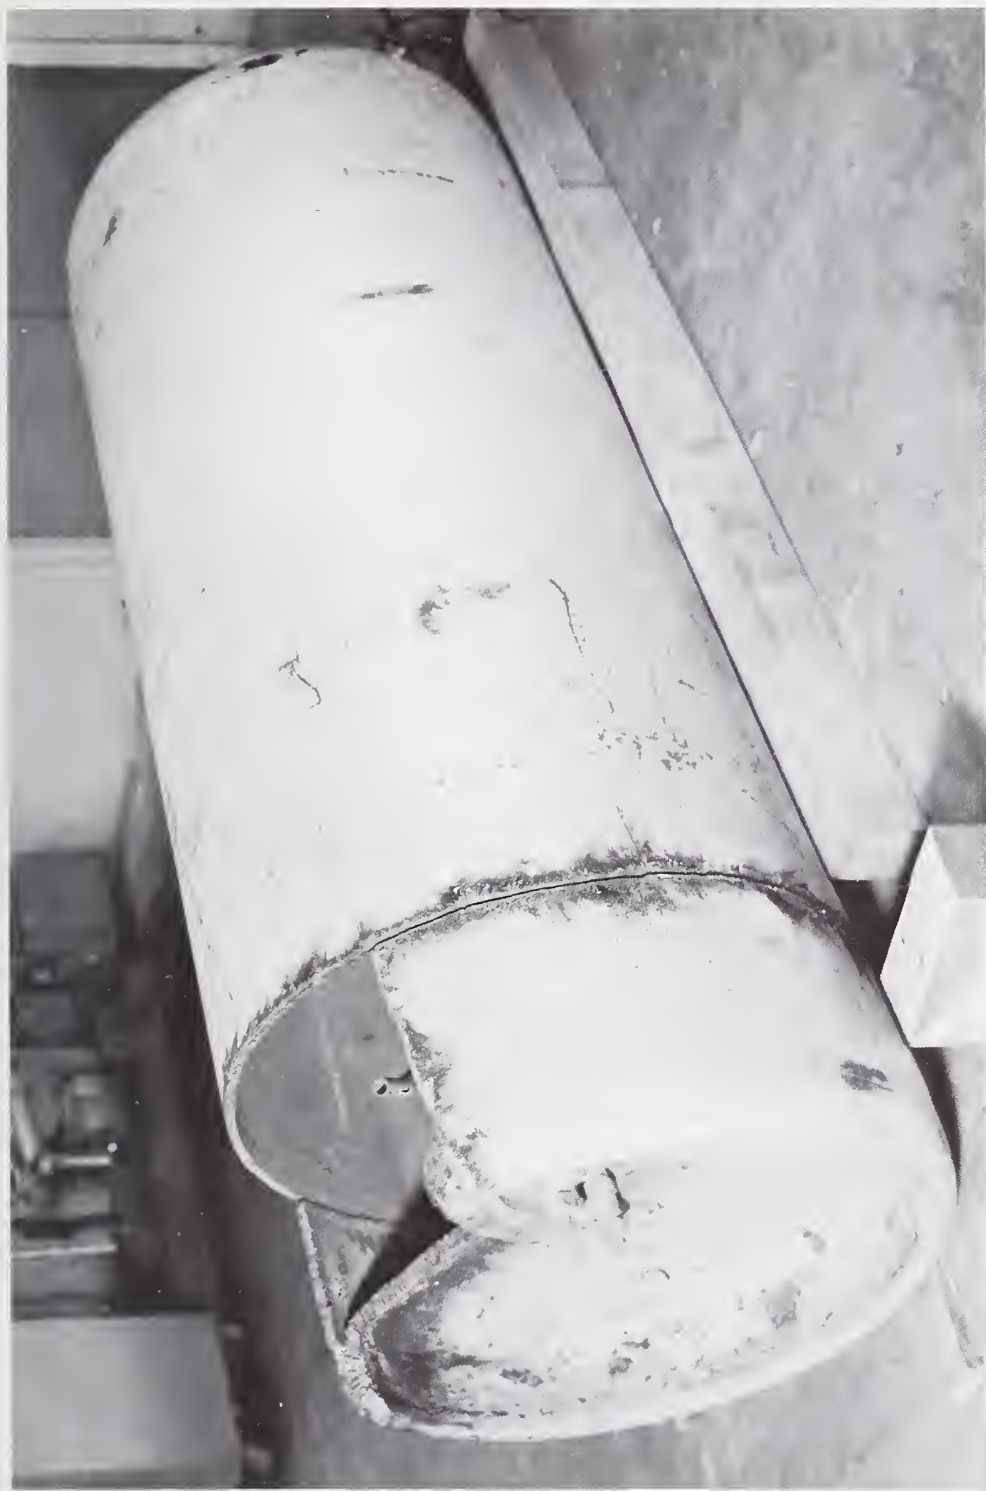
Figure 1. The tank after flame cutting to remove the end that leaked and the section that contained the leak.

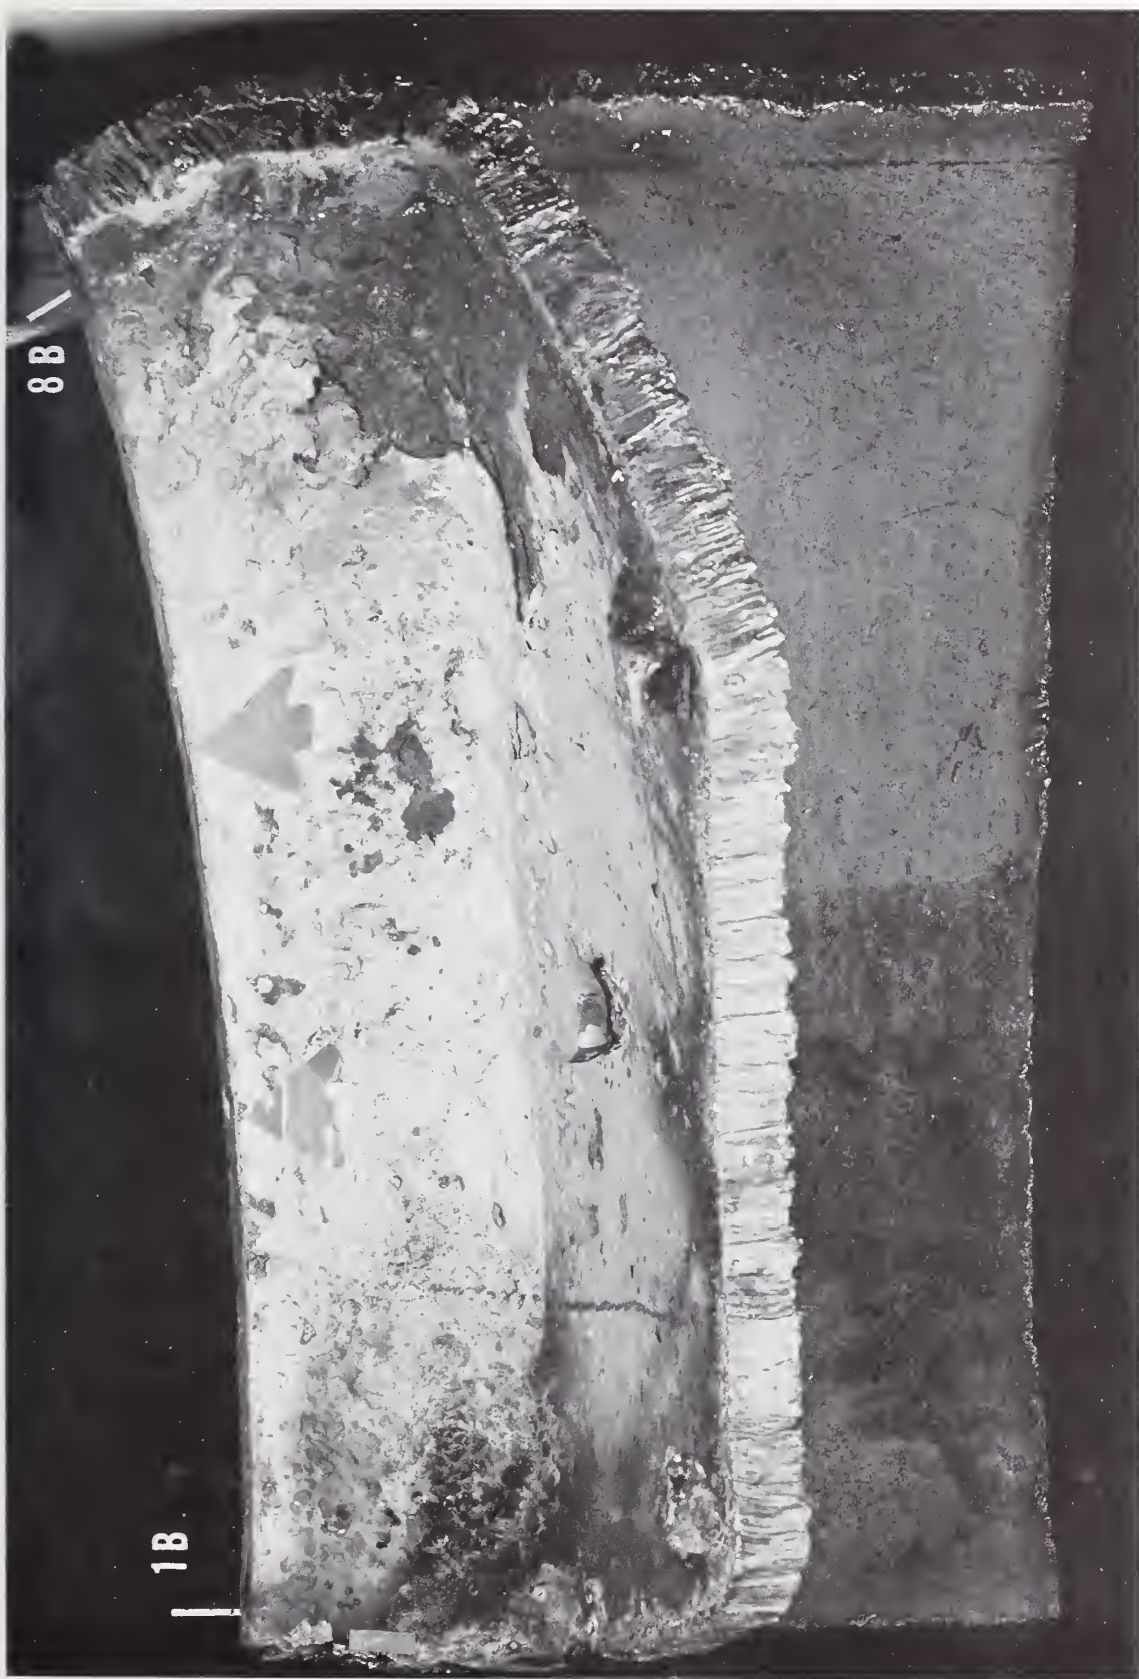
Visual examination of the external parts of the tank revealed that the exact location of the leak on the end of the tank was not readily discernable. Between the two marks that had been placed on the end of the tank to locate the leak, there was a region of about 2 inches (5 cm) in length from which the paint on the surface of the tank had been removed. It was presumed that the peening hammers used to close off the leak had chipped this paint loose. This peened region is contained mainly in segments 4 and 5, and so it was tentatively concluded that the tank had leaked in segments 4 and 5.

Figure 2. The section that contained the leak, as flame-cut from the tank. The leak occurred on the end of the tank between the two arrows.

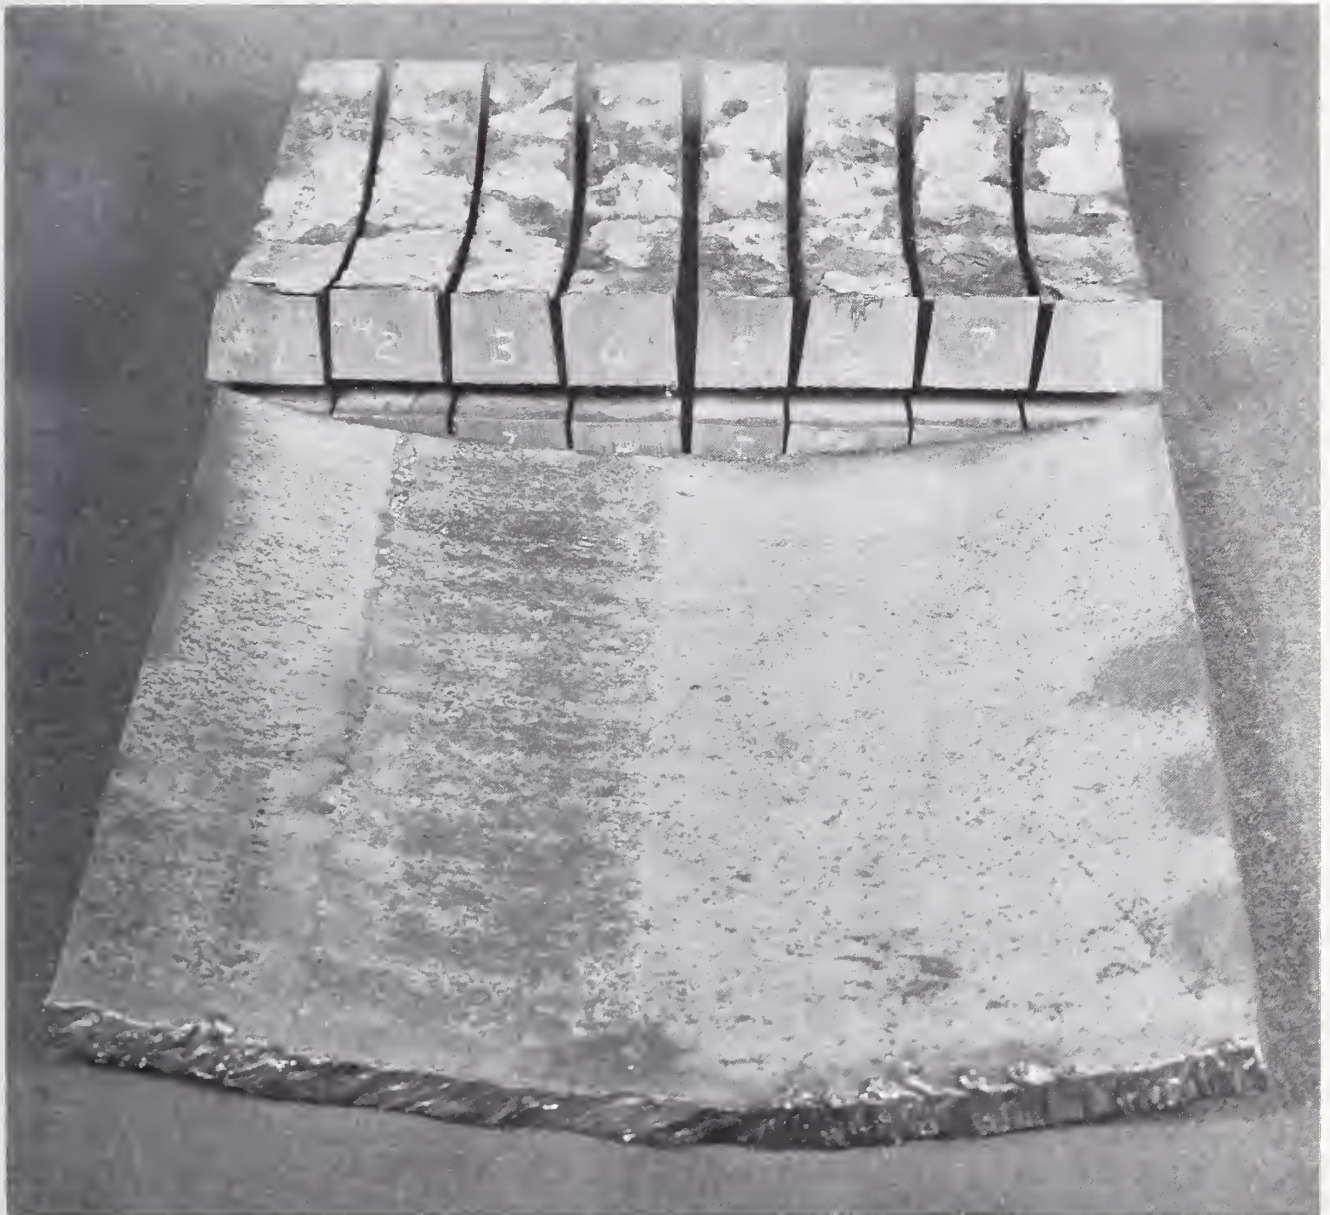
Midway between segments 4 and 5 inside the tank, a corrosion line was observed. This line can be seen in Figure 3 on the plate in front of these segments, and it can be seen in Figure 6, which shows the inside of the

Figure 3. Eight 1-inch segments as saw-cut from the section that contained the leak. Part of the shell plate that adjoined these segments is also shown.

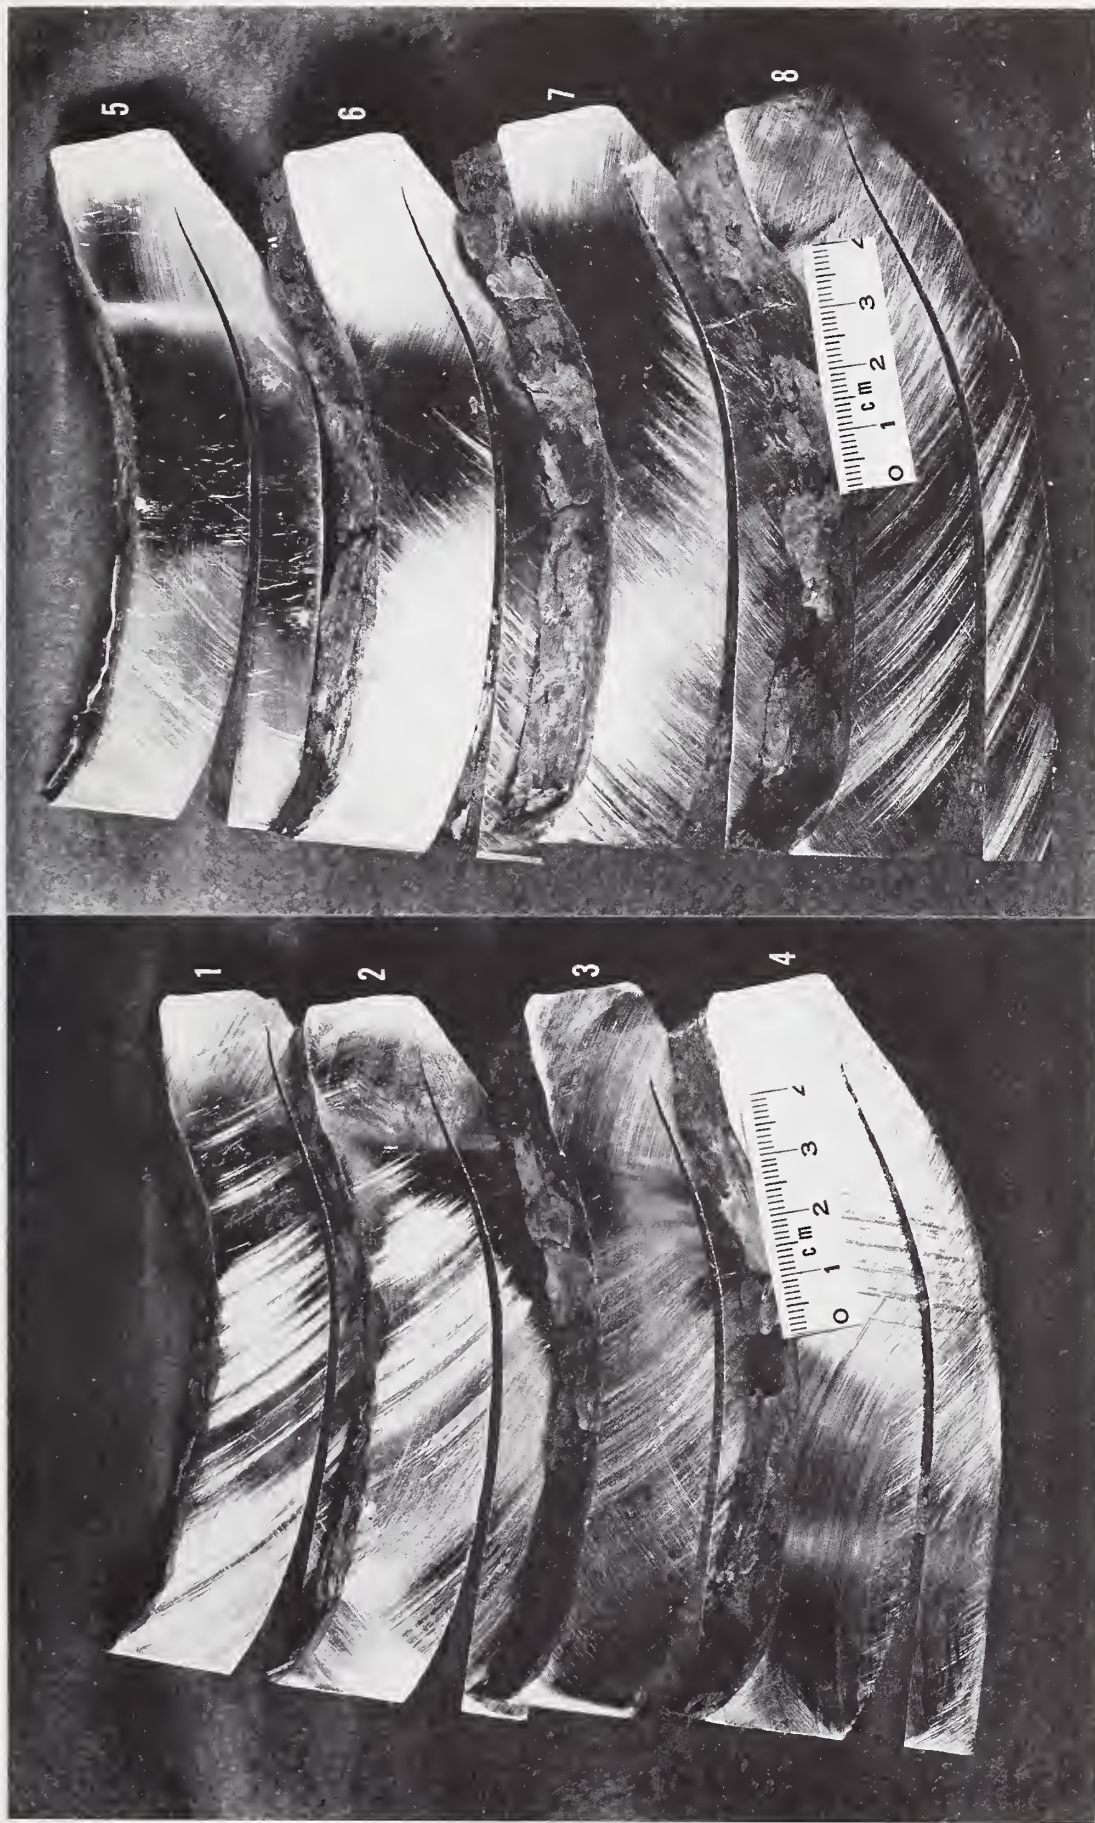
Both the rough-ground segments of Figure 4 and the polished segments of Figure 5 show that the bonded region extends for less than 0.4 inches (1.0 cm), in segments numbered 1 through 7, and for about 0.6 inches (1.5 cm), in segment number 8. The shortness of these lengths of the bond line are somewhat surprising, especially for segments 2, 4, and 5 which have bond line lengths of less than 0.2 inches (0.5 cm).

Figure 4. Eight 1-inch segments in the rough-ground condition.

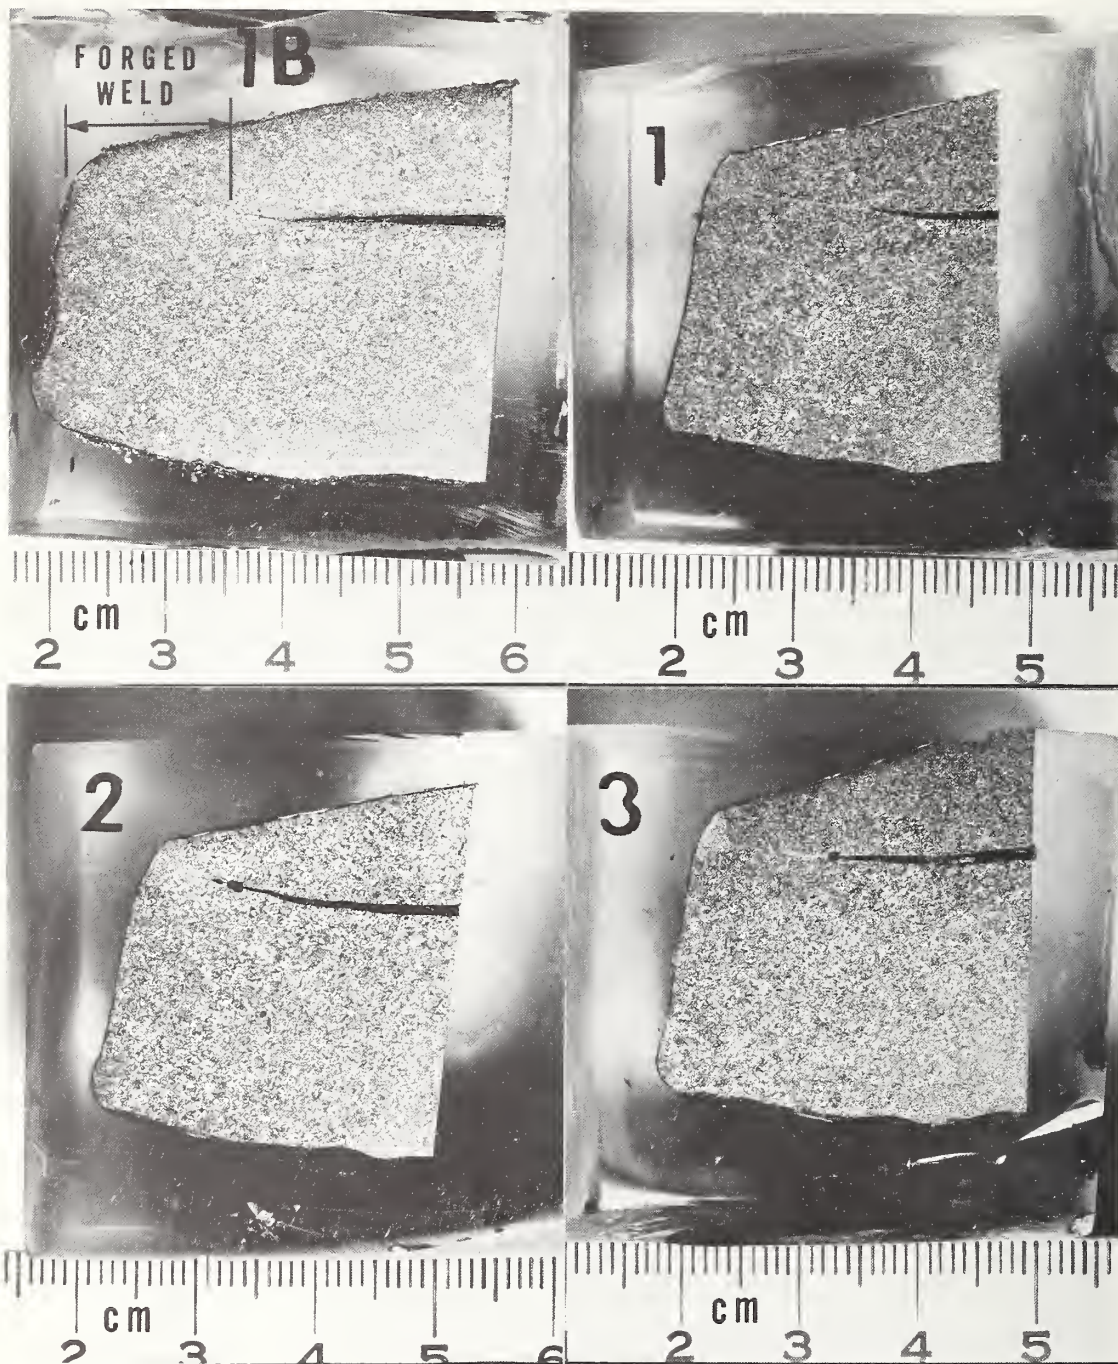
In the polished and etched condition (Figure 5), segments numbered 2, 4, and 5 were observed to have no fusion from lap welding, i.e. no forged weld region. The bonded metal shown here for these three segments is that of a tac weld at the end of the vessel. The other segments examined had at least some small length of forged weld metal along their bond lines. Segments 1B and 8B were taken from the ends of the original flame-cut section at distances somewhat remote from the leak, as marked on the photograph of Figure 2. In Figure 5, the polished and etched faces of these two segments clearly show forged weld metal in lengths of 1.3 inches (3.3 cm) for 8B and 0.6 inches (1.5 cm) for 1B. Segment 8B is more distant from the tac weld than any of the other segments examined, and 8B has the longest forged weld region.

Figure 5. Eight 1-inch segments from near the leak and two end segments taken from the section that contained the leak, in the cropped, polished, and etched condition.

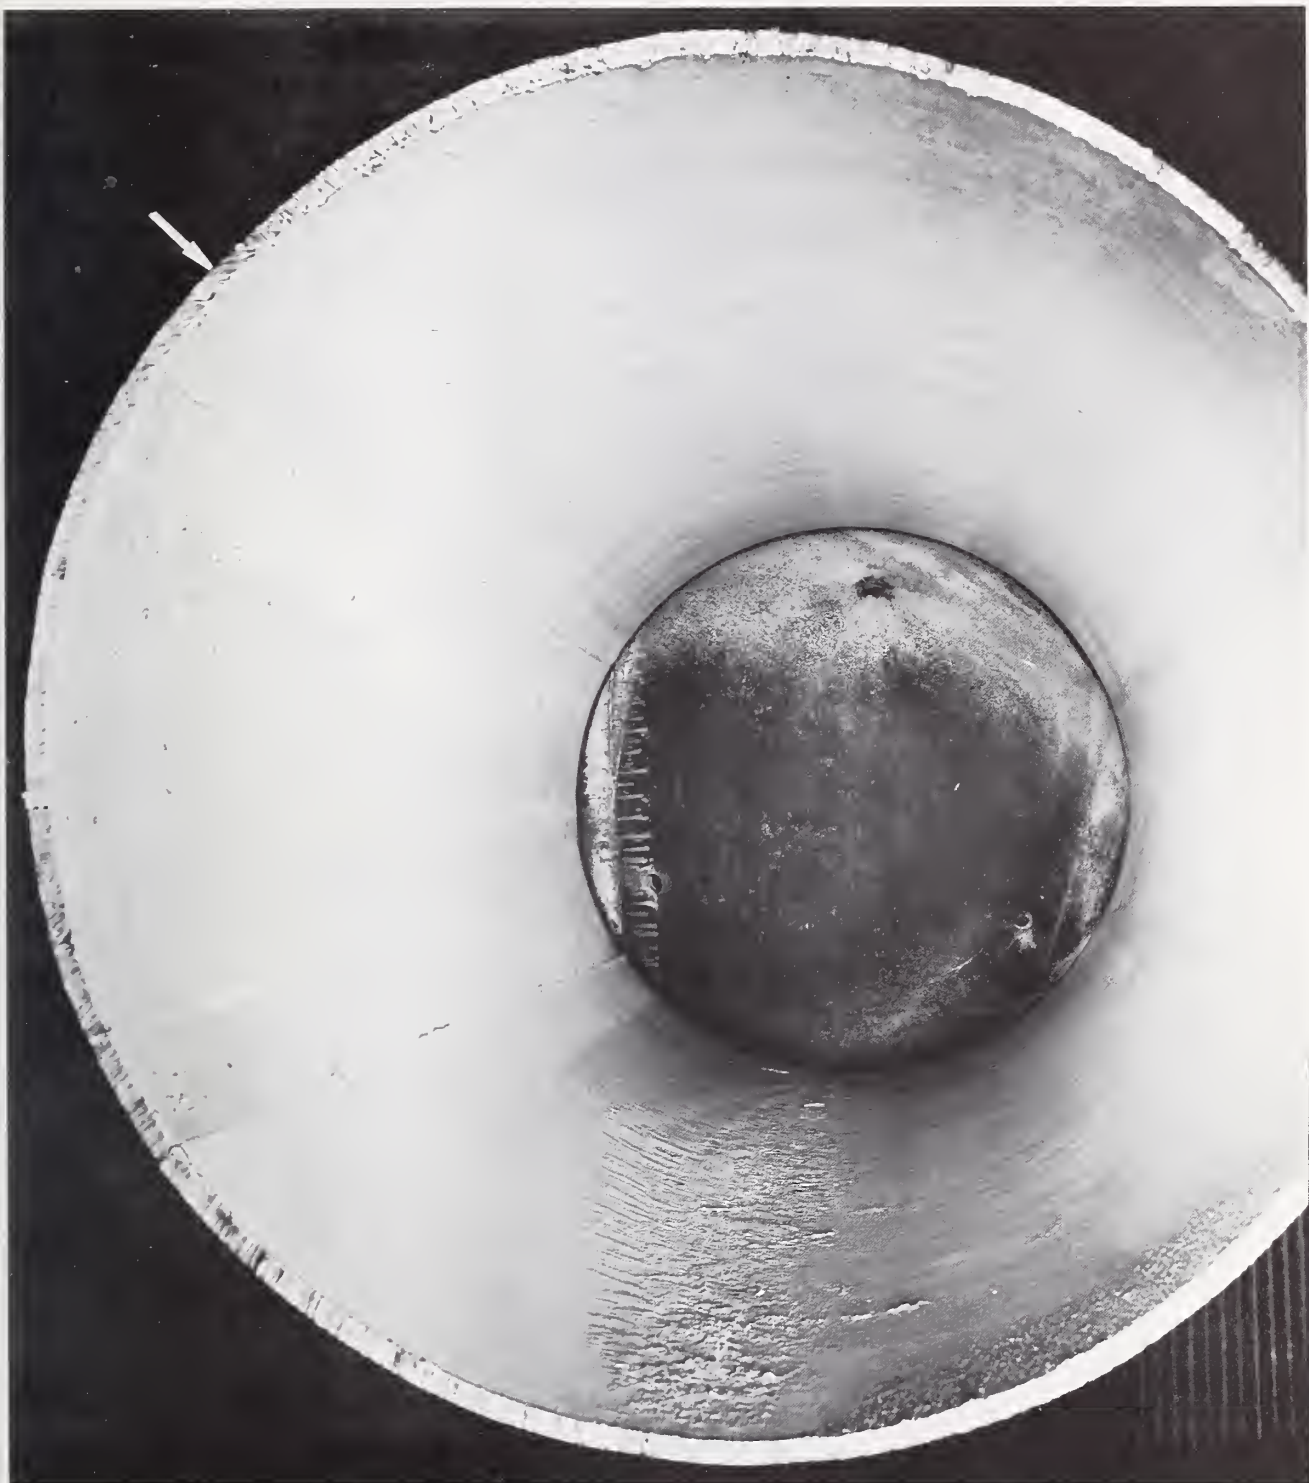
remainder of the tank after removal of the end that leaked. In Figure 6, this line is marked by an arrow. The line is bounded by two circles--one is the flame-cut shell plate and one is the head plate at the far end of the vessel--and the line is approximately midway between the 10 and the 11 o'clock positions on the circles.

Several cycles of corrosion are apparent in Figure 6 on the inside of the tank. Each cycle is believed to represent corrosion that occurred while the tank was partially filled while being stored flat along the long axis of the tank, and it appears that with each cycle, corrosion products were formed over a segment of the inside surfaces of a partially filled cylinder. Thus, at a previous boundary between the filled and unfilled parts, there exists a line, which is visible evidence of a difference in the corrosion experiences of the metal on the two sides of the line.

Figure 6. Inside of tank after removal of the end that leaked. The arrow marks a faint corrosion line located at saw-cut boundary of segments 4 and 5, which were taken from the flame-cut section of the tank. This arrow is also approximately centered on 2 white marks at 9 o'clock and 12 o'clock. These marks show the limits of the flame-cut section.

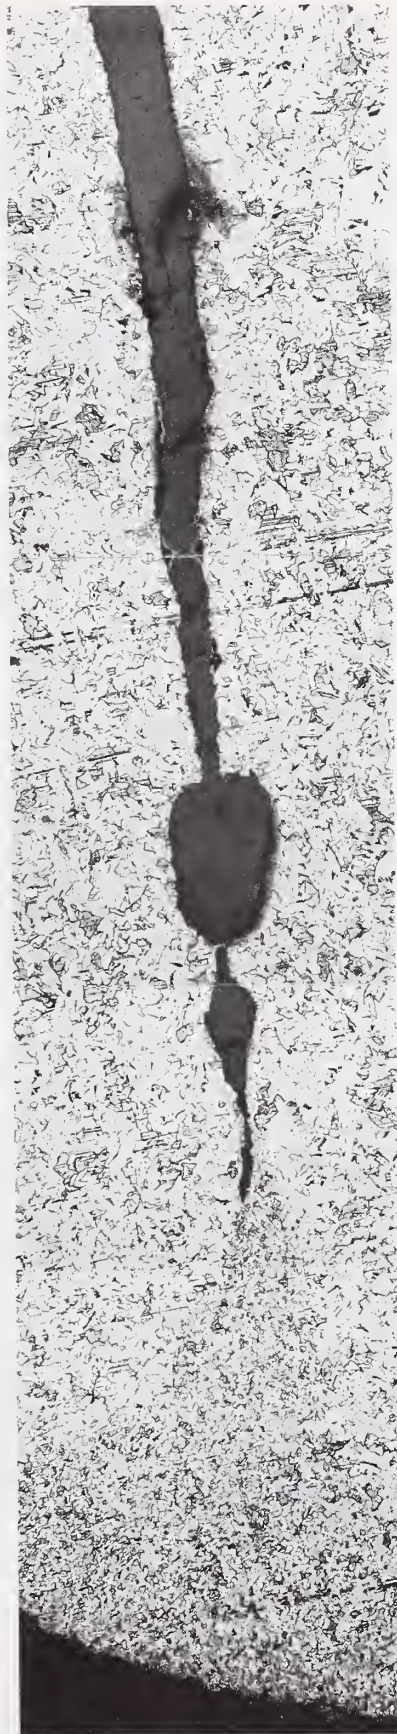
A montage of photomicrographs was taken on face 1 of segments 2, 4, and 5, each of which were bonded only by a tac weld with no lap weld being present. These montages are presented, respectively as Figure 7, 8, and 9. They show that the unbonded region extends (from inside the tank) to the root of the tac weld of segment 4 face 1, and that the unbonded region extends beyond the root of the weld for a short distance along the fusion line of the tac weld in the other two segments. They also show, in the corroded forged weld regions near the tip of the unbonded part, that somewhat enlarged cavities have formed, presumably by corrosion that occurred in these regions at a rate greater than the rate at which it occurred at other nearby locations. These local regions, such as is shown near the tip of the crack of Figure 7, have a geometry that restricts the access to the bulk of the interior space of the tank. The formation of cavities such as those shown in Figure 7 is not unlike that observed in crevice corrosion.^{1,2)} It is well known that mild steels are susceptible to crevice corrosion.³⁾

Figure 7. Montage of bond region on segment number 2, face 1.
X 40

Figure 8. Montage of bond region on segment number 4, face 1.
X 40

Figure 9. Montage of bond region on segment number 5,
face 1. X 40

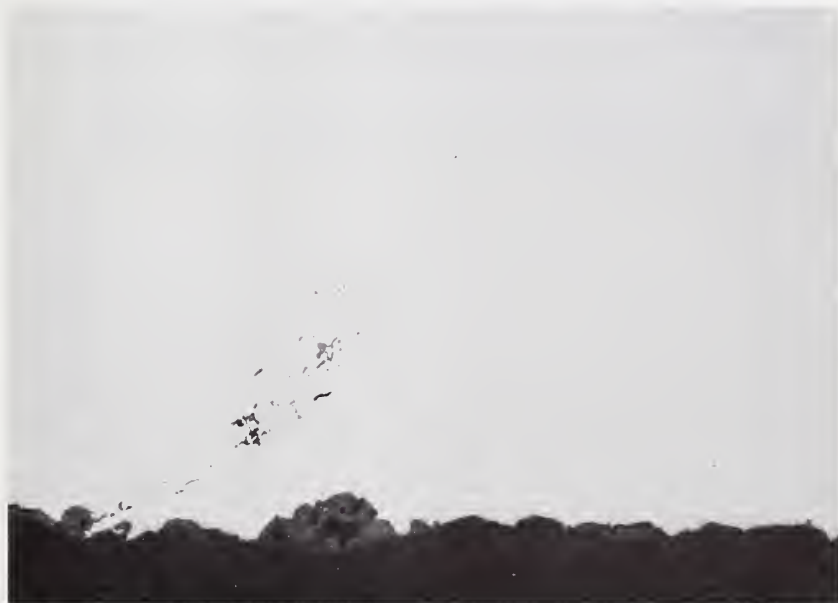
layers beneath the level of the fracture face of the weld metal. In several of these layers there existed weld-metal with gross porosity and oxidation which extended from outside of the tank on the face of the weld to within the tac weld metal. After successive weld-metal layers were removed microporosity only was present. Figure 11A shows the region of porosity at one level at which it extended to the outside of the tank and Figure 11B shows the region at another level at which it was essentially contained within the weld metal. Surrounding the pores there is evidence of corrosion. While this corrosion could have been the result of some externally prompted corrosive action, we suspect that it may be a result of internally prompted corrosion, and that it may be the actual site of the leak. However, the micropores observed at the internal weld metal site were not successfully traced all the way to the root of the tac weld inside the vessel.

Figure 11. Two sections taken in the weld metal on the head-plate portion of fractured segment 5, showing surface (11A) and sub-surface (11B) defects and oxides that surround them.

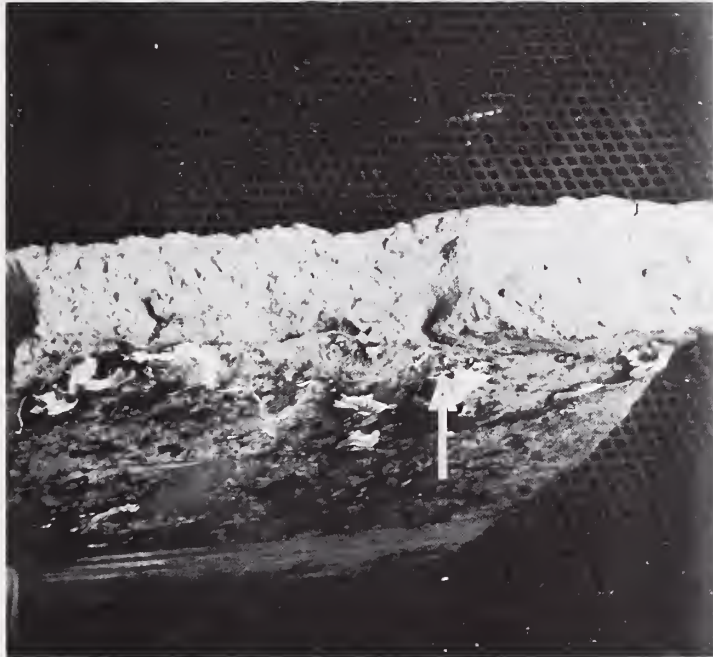
Figure 12 shows the fracture face on the shell portion of segment 5 at a magnification of X5. The arrow on the figure points in the direction of crack propagation (during separation from the inside to the outside of the tank) and it is located at the dark part shown at the arrow on Figure 7. At higher magnifications, Figure 13 shows that this dull region is non-crystalline whereas other parts of the fracture are crystallographic. Microporosity is much more prevalent in the dull region. This microporosity and the dimpled appearance of the dull region is shown at X1300 in Figure 14A, and the crystalline appearance of the balance of the fracture is represented at X1300 in Figure 14B.

Figure 12. SEM fractograph of fracture face of segment 5 taken at X5 magnification. The arrow points in the direction of crack propagation and it is located at the "dark part."

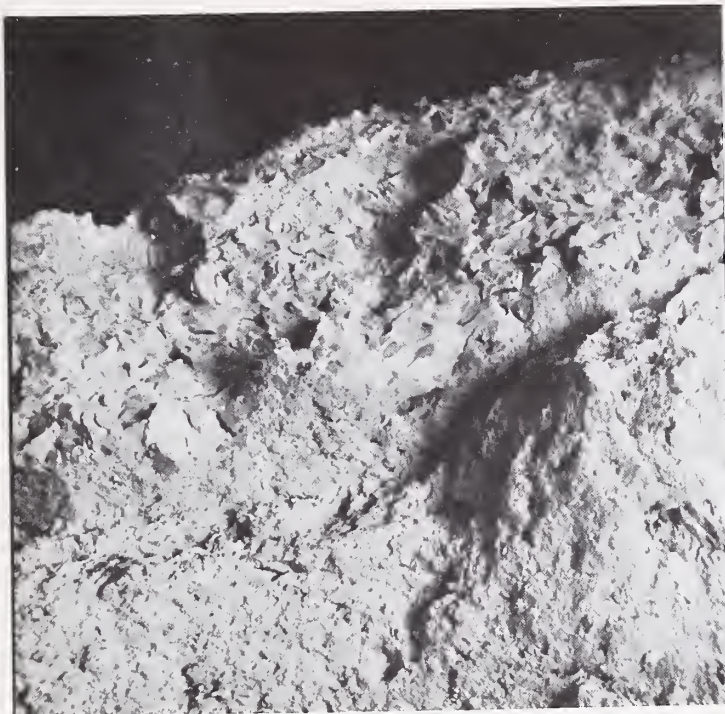
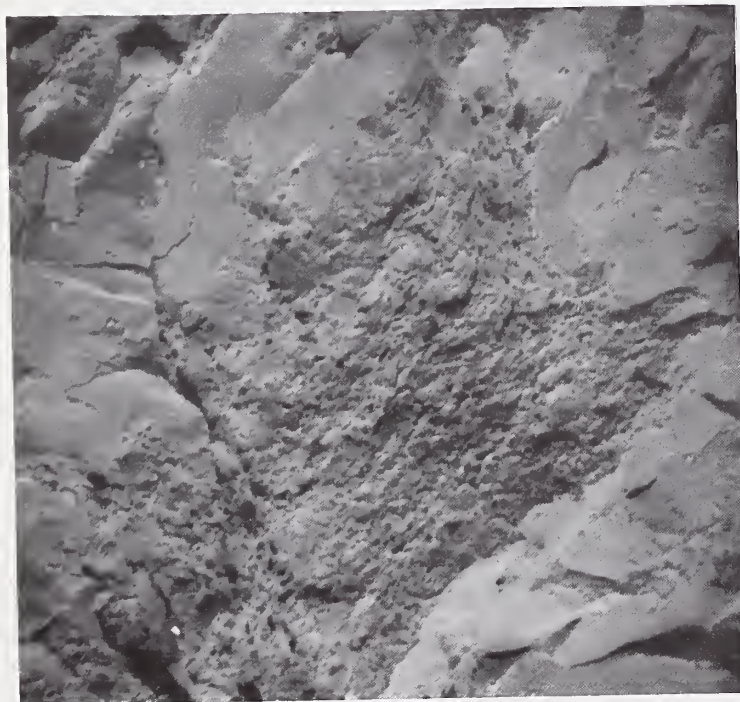
Figure 13. SEM fractographs taken at X48 (Fig. 13A.) and X240 (Fig. 13B.) showing microporosity in the dull region and crystalline fracture in the adjacent parts of the fracture.

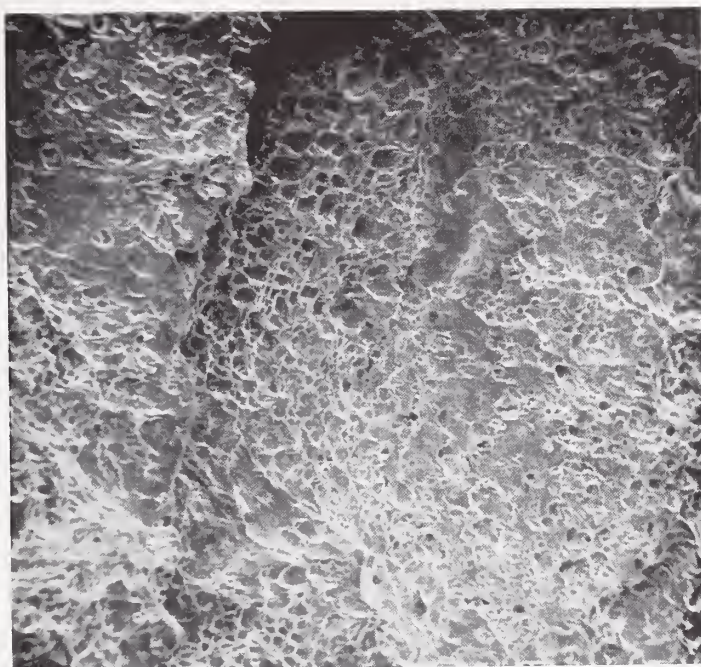
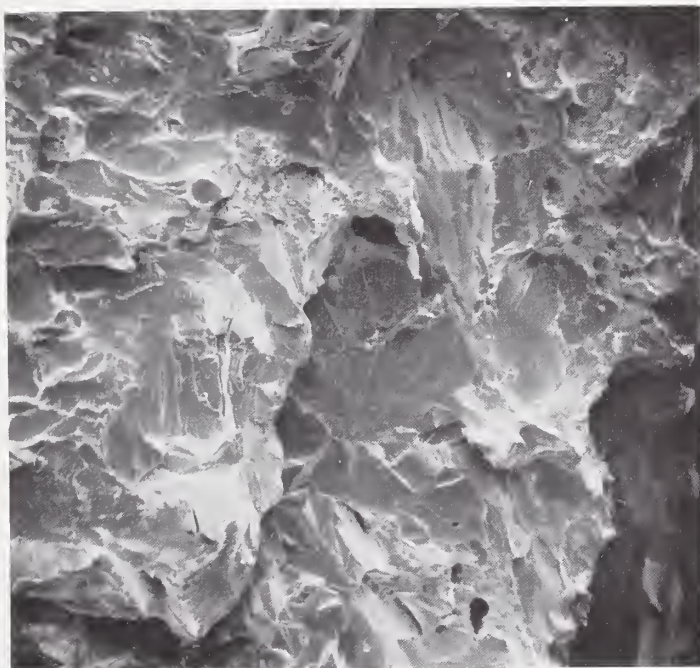
It is believed that the dull region failed in a more ductile manner than did the balance of the fracture because constraint was locally decreased in this region due to the presence of the micropores that existed before the two pieces were separated to form the fracture faces. This microporosity

was probably present in the original tac weld, just after the weldment had been deposited. In service, it is believed that corrosion acted on this region of porosity eventually to form a continuous path from the interior to the exterior of the tank.

Figure 14. SEM fractographs of the dull region (Figure 14A), showing microporosity and dimpled rupture, and of a region representative of the balance of the fracture (Figure 14B), showing a crystalline appearance.
